## **Cape Breton Regional Municipality + You. Moving Accessibility Forward.**

**Final Accessibility Action Plan for the Cape Breton Regional Municipality (CBRM)**

**Submitted by: reachAbility Association**

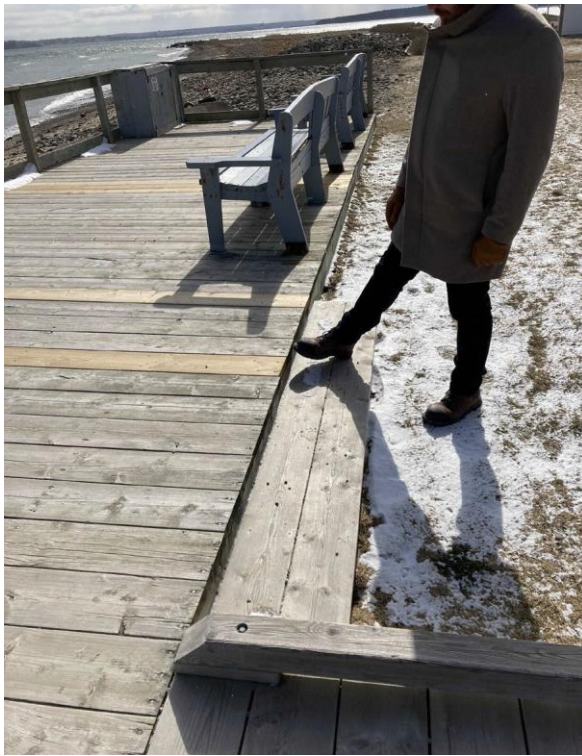
### Community Halls and Recreation Centres

- There are a number of small transitions that require accessible access or a cane detectable railing used.
- The pebble or gravel ground covering is inaccessible to anyone with mobility barriers.
- There are no contrasting, tactile indicators or railings on any of the stairs. These accessibility features are required no matter how small the staircase.

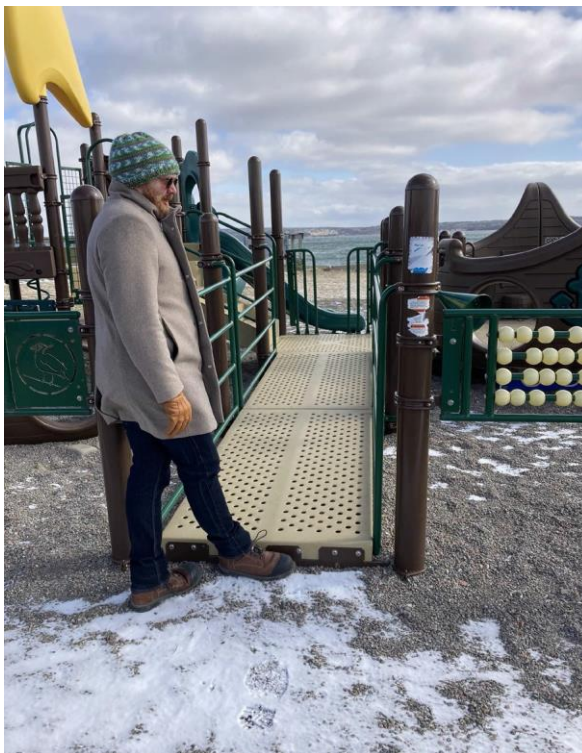
- The pebble or gravel ground is not a suitable ground covering around ramps as it moves when walked on, and leaves barriers and large transitions between levels as seen in the photo on the left.
- More wayfinding would be helpful, ensuring that signage has appropriate contrast.
- Some buildings have doors with door knobs, they should all be switched to have consistent door handles.
- There were no clearly marked bathrooms, however there were a number of buildings so there could have been one.
- The canteen counter is too high for equitable access.

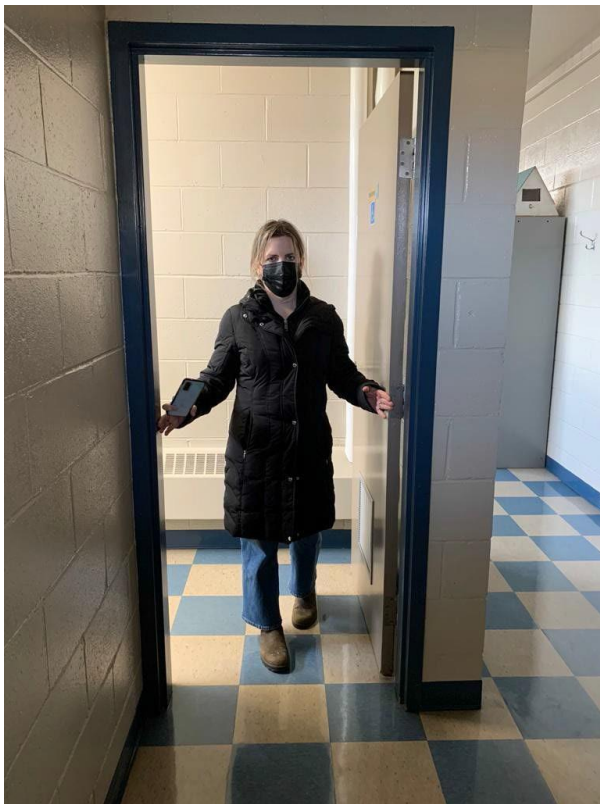
- Narrow doorways.
- Insufficient signage and wayfinding.
- A lot of clutter near the entryway.
- Heavy doors.
- Accessible viewing area for the pool, but narrow hallway with odd barriers in passageway caused by structure of wall/ductwork in order to get to the viewing area.
- Very little signage or wayfinding anywhere.

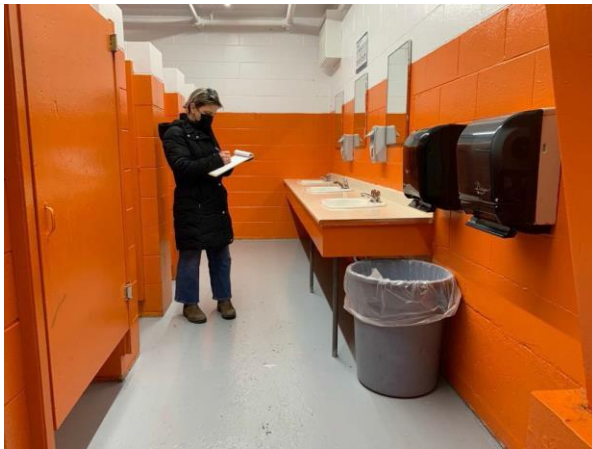
## Community Halls and Recreation Centres

- Bathroom stalls not accessible widths for accessibility and passageways do not provide enough turn radius or room for travel.
- Sinks are not accessible. Removing the trim around the front and sides of the vanity would provide appropriate knee clearance of 685 mm.
- Bathroom doorways are too heavy.

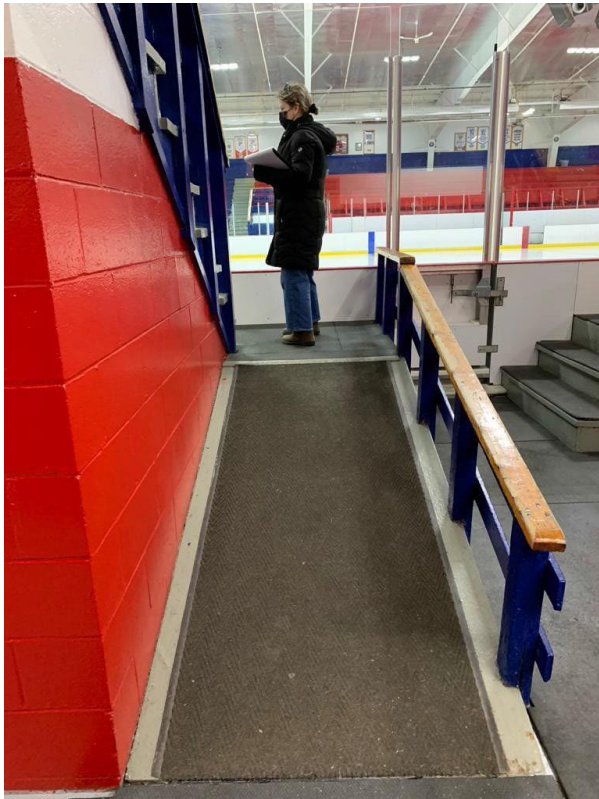
- Ramp provides access to rinkside accessible seating but ramp is not to code. The incline is above the 5-6% maximum and the railing is below the appropriate height, by almost half.
- Contrast is needed on the ramp and on all stairs.
- Changing rooms could be adapted to accommodate an accessible shower by moving the stall wall out another 8-9" which is possible to do in its current state.
- AED is too high. It is currently approximately 1700 mm high and the maximum height should be 1100-1200 mm
- The box office and canteen counters are too high.
- Stairs do not have adequate contrast, tactile indicators or railings.

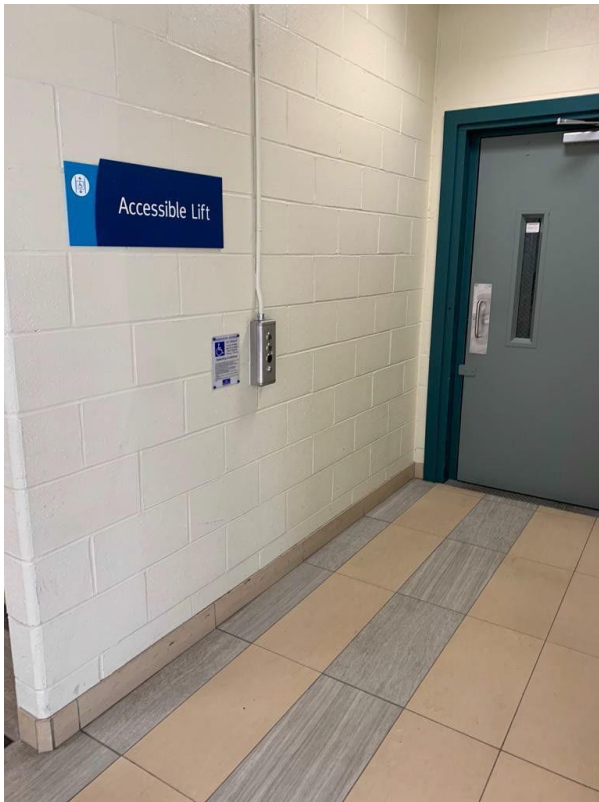
## Community Halls and Recreation Centres

- The parking lot has designated parking spaces but do not have the required posted signage.
- Accessible lift available for visitor use. However the need to find the manager and request the key is quite inconvenient for the person needing to use it.
- Wayfinding signage has directional arrows worn off.
- Stairs to access the second level outside of the rink have railings on both sides but have insufficient contrast and tactile indication.
- Bathrooms need L shaped bars, adequate turn radius and transfer space, toilet seat covers or tanks on toilets, adequate knee clearance on sinks, amenities like soap, paper towel, etc. at accessible heights.

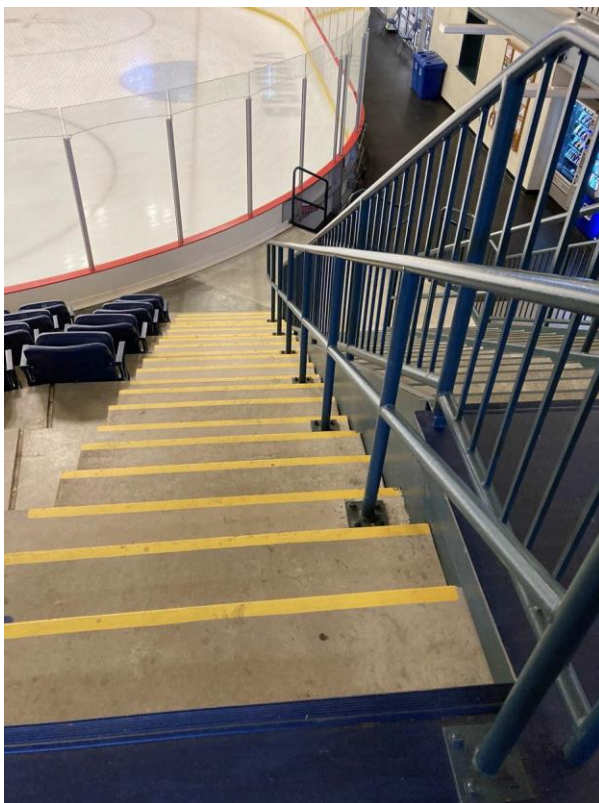
- Stairs to arena seating have adequate contrast on stairs but needs contrast at top and bottom as well. Additionally, tactile indicator strips should be replaced regularly and included at the top and bottom as well.
- The railing from the arena seating steps extends beyond the railing of the adjacent set of stairs leading to the upper level and causes a hazard for passersby, especially those with a visual impairment or blindness.
- Ramps and stairs on second level, outside of the arena space, do not have appropriate contrast or tactile indicators and the stairs don't have railings as required.

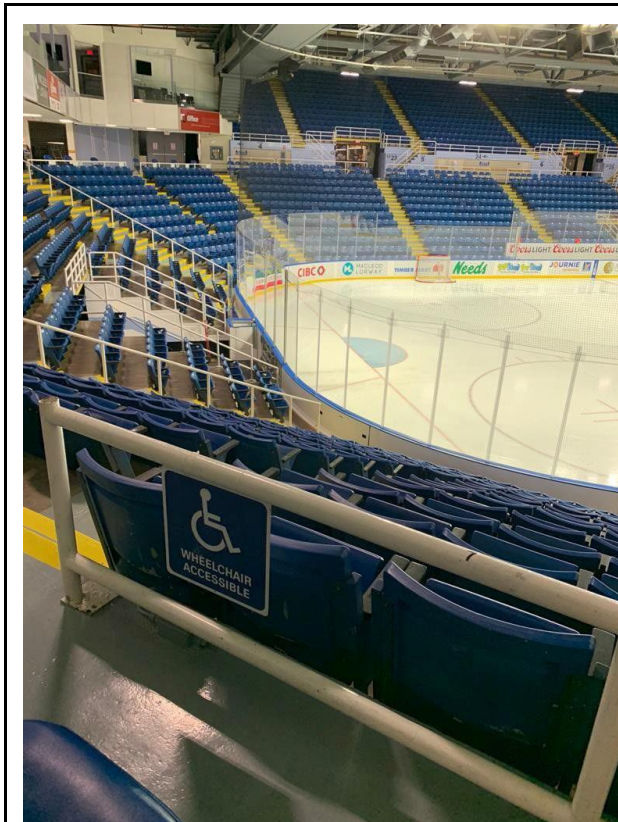
## Community Halls and Recreation Centres

- Stairs in the arena do not all have railings equitable access.
- Stairs in the arena do not have tactile indicators.
- Accessible seating at the top of the lower bowl seating has an unsafe railing in front of it. It is less than 610 mm and the appropriate height is 920 mm.
- The box office and canteen counters are too high.
- There needs to be clear signage inside the main level bathrooms.
- Accessible bathroom stalls need toilet seats or tanks on the back for improved stability, L shaped transfer bars.

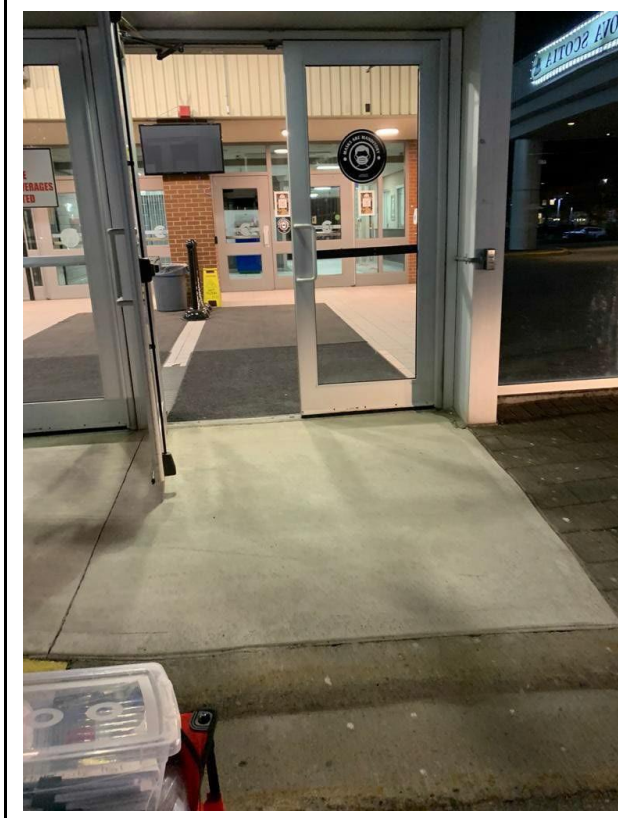
- There are no visible rinkside accessible seats.
- Rear entrance does not have door opener buttons.
- Entrance/Exit doors for the arena do not have door opener buttons.
- The main entrance has a slight incline in before the door open button and does not have enough space between the door and where the incline is for safe access.
- There is no safe passageway from the parking lot to the main entrance unless you travel from the Casino side of the building along the sidewalk, and this is a long way to walk with no rest areas.
- Wayfinding within the space could be improved.

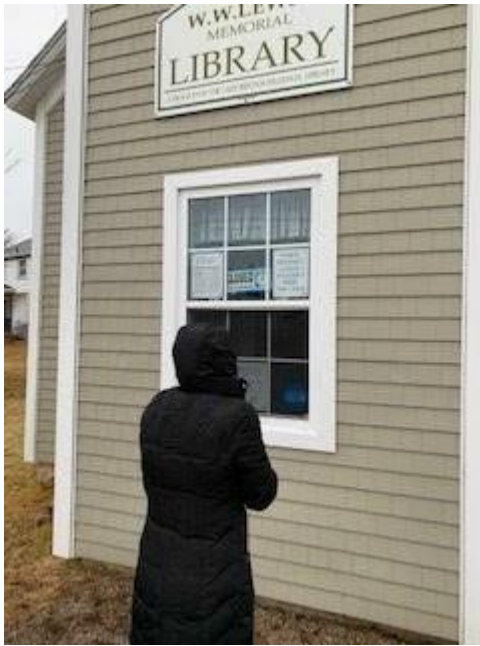
## Libraries

- There is no designated parking at all for this location. There is also no sidewalk leading to this building, or on this road so users must park on the shoulder or in the driveway which would fit one car.
- There is very little signage identifying the building or the entrance.

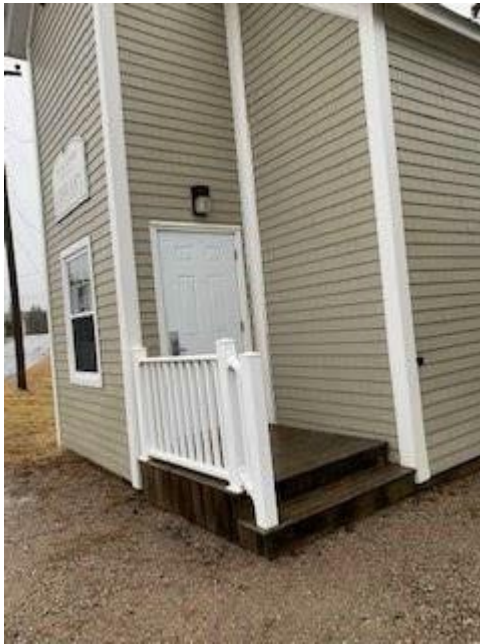
- There is only one entrance/exit to this building.
- There is no accessible access for someone in a wheelchair or with moderate to severe mobility issues to be able to access this space.
- The stairs do not have appropriate railings, contrast on the stairs or tactile indicators.
- The yard has a few picnic tables and/or seating areas, however the "yard" is not overly accessible as it is very uneven ground.

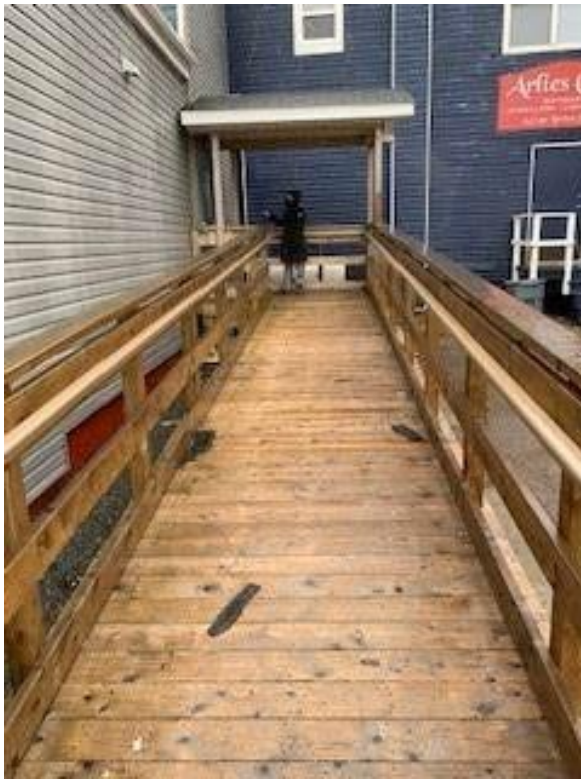
## Libraries

- The ramp providing accessible access to the library from the parking lot requires tactile indicators and contrast at the beginning and end of the incline. Also, due to the wooden material used for the ramp, it needs to have anti-slip material on the ramp to eliminate the risk of injury when using it when it is wet.
- There is no signage or wayfinding identifying this ramp as the accessible entrance to the library. The main entrance is on the other side of the building.
- There is no safe, identified passageway from this ramp to the parking lot/accessible parking spaces.

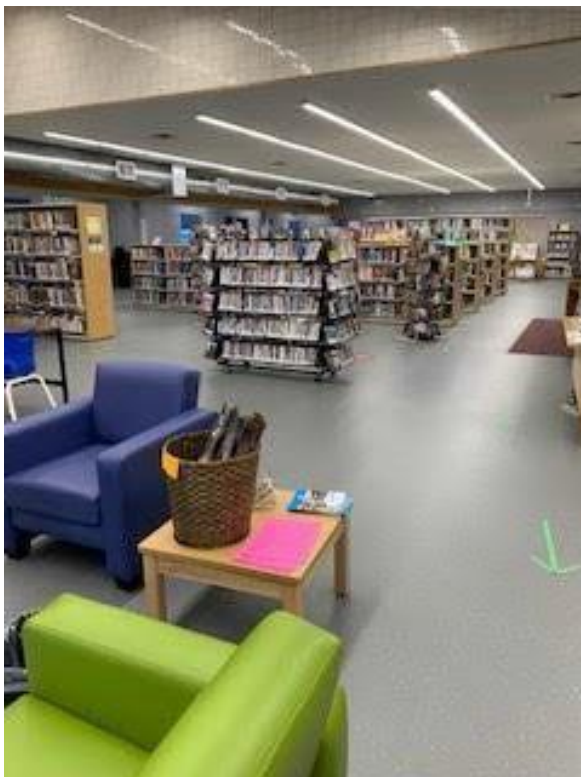
- The door opener button for the main entrance is not easily located and should have a sign indicating where it is.
- There is a chair in every aisle of books which causes a barrier and impedes the turn radius for someone in a wheelchair.
- Signage indicating the various genres on the shelves is not at accessible heights, nor of consistent size/font/contrast.
- Some of the bookshelves are too high.
- There were no designated accessible parking spaces visible within the parking lot to the rear of the library.
- There is another exit on one side of the building that has two stairs and a small ramp, neither of which have a railing or tactile indicators.

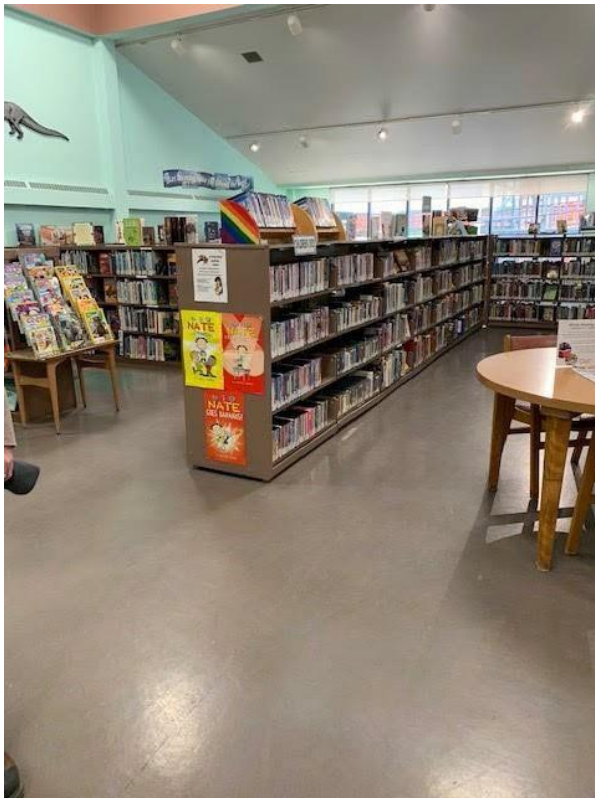
## Libraries

- The ramp to the main entrance is too steep, the railings are not to code, and it needs a landing area for rest.
- The main library space is too cluttered to allow for accessible passageways.
- There were benches in each aisle of books causing a barrier for anyone using a mobility device or wheelchair when trying to access the books.
- Most of the bookcases were too high in the main library area and should model the same height as the bookcases in the children/youth section.
- The book sale area is too crowded for able bodied people to move around let alone someone in a wheelchair.

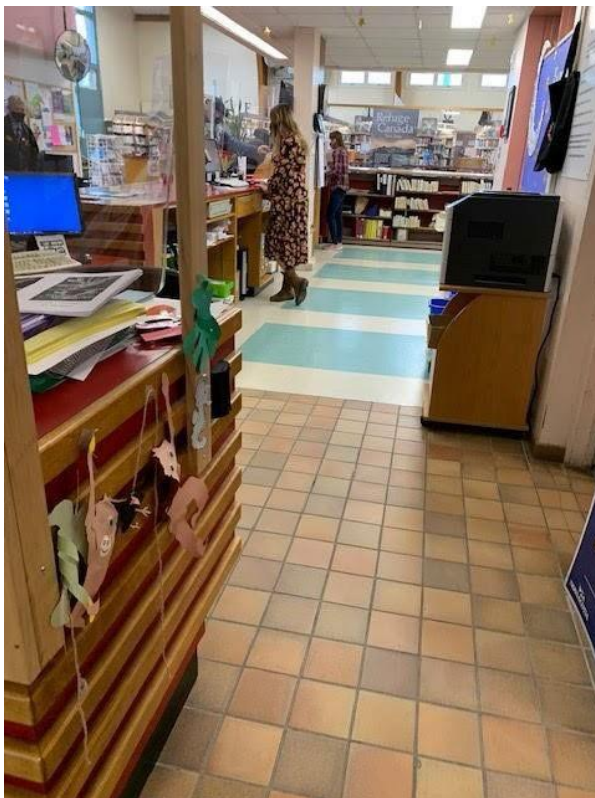
- The counters at the library staff work space are too high for accessibility.
- There is no elevator providing accessible access to the lower level which serves as the headquarters for the Cape Breton Regional Libraries.
- The entrance/exit to the lower level is also not accessible.
- Fire extinguishers are not encased or recessed in the wall.
- The door opener buttons for the main entrance are almost hidden in their current location and should be more clearly labelled or moved.
- The stairs and ramps inside and outside need adequate contrast and tactile indicators at the top, bottom and on all stairs.

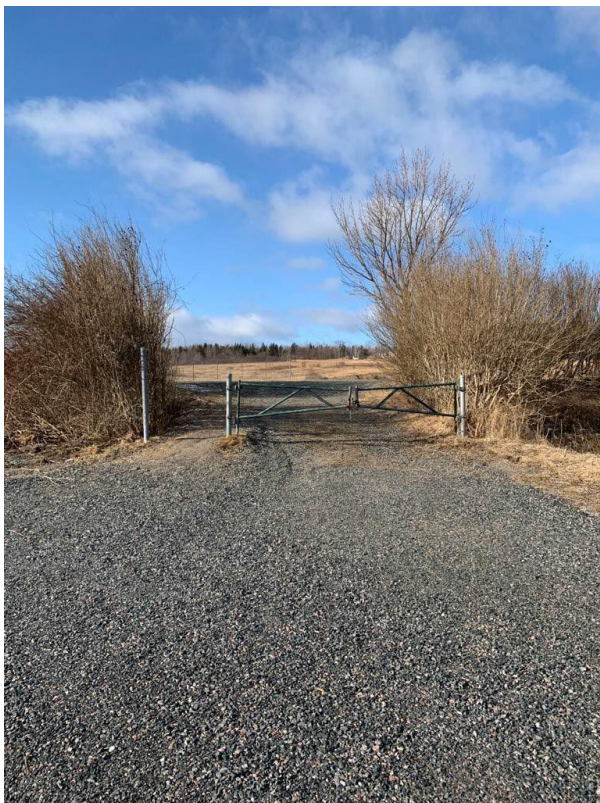
- There is no designated parking or even signage referring to parking being allowed at this location.
- The entrance from the parking lot up onto the walking trail and the fields is not accessible. It's not stable ground and is quite inclined - this could possibly be paved or the incline levelled.
- Currently there are two fields, one could easily be converted to a soccer field with the baseball field being updated so that the diamond can be used. Otherwise, we would suggest completing the fence and creating an off leash dog park for the community.
- There needs to be rest areas along the trail/path no more than 30 metres apart with ample waste receptacles also available.

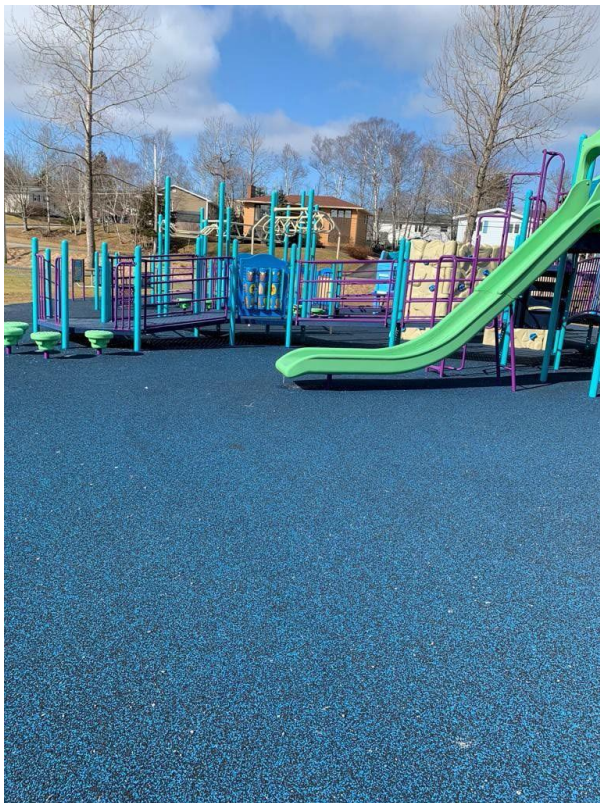
- There isn't any accessible seating at this playground. The addition of a variety of rest areas, including accessible picnic tables would really improve the quality of time people spend here.
- The swing sets and former playground area that are still very useful are disconnected from the new accessible playground. There needs to be connectivity between these two areas so that no one is being excluded from playing together.
- There aren't any sidewalks or crosswalks leading to this playground for those who are travelling by foot, bicycle or wheelchair.
- There are no washrooms at this location let alone accessible bathrooms.

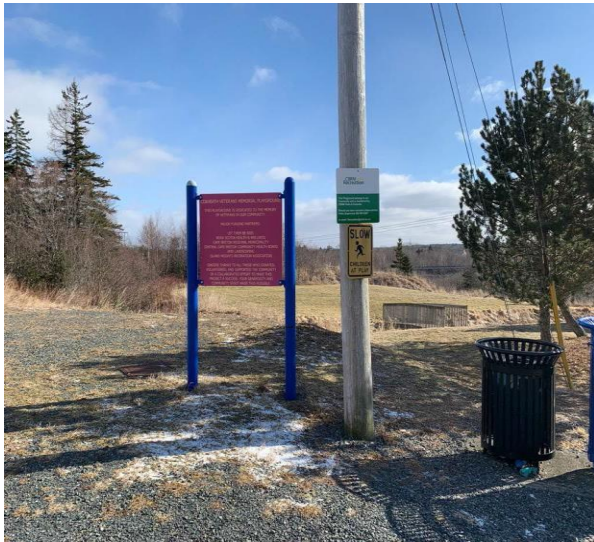
## Parks & Playgrounds

- Contrast on signage is insufficient for individuals with low vision/visual impairment.
- Garbage receptacles are too high.
- The terrain in this area is very uneven and unstable, making it difficult to walk on and/or travel across while using a wheelchair or mobility device.
- The bridge leading to an unknown area has a transition from the ground to the structure preventing barrier-free access.

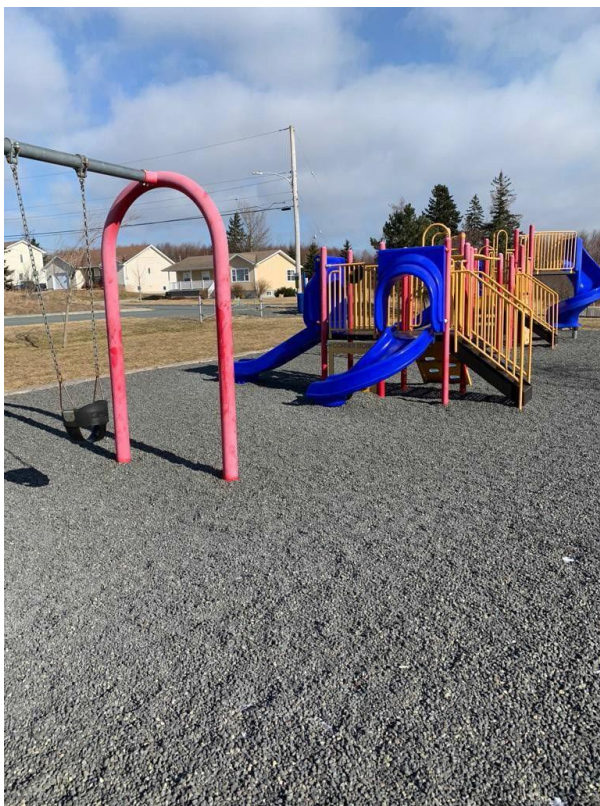
- There are no accessible play options. Someone with a physical disability who requires the use of a mobility device and/or someone who is visually impaired or blind, would have no options for independent play here.
- The pebbles or gravel used as the ground for this playground causes barriers for anyone who is unstable on their feet.
- The wooden base that is used to contain the pebbles/gravel needs to have an opening on each side to allow barrier-free access for anyone who can not independently use steps to access this area.
- There is no accessible parking, sidewalks leading to this space, or washroom amenities.

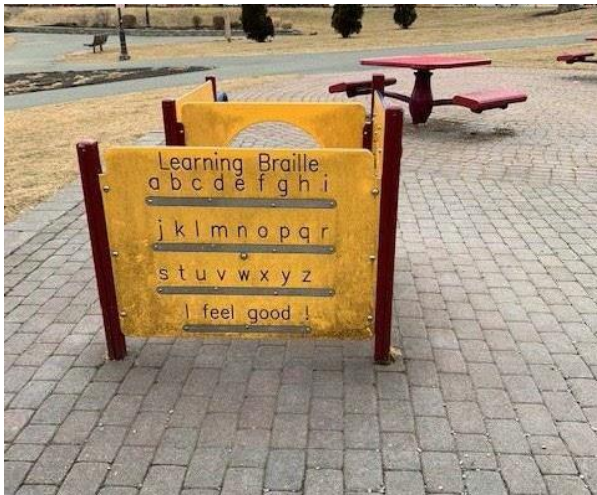
## Parks & Playgrounds

- There is very little wayfinding, signage or identifying markers. We didn't realize there was a second piece to the park on the other side of the road.
- The play area does not provide a lot of options for accessible play.
- The brick platform of the play area can cause hazards if not well maintained.
- None of the stairs have contrasting or tactile indicators and some have wear from the weather that is creating a hazard.

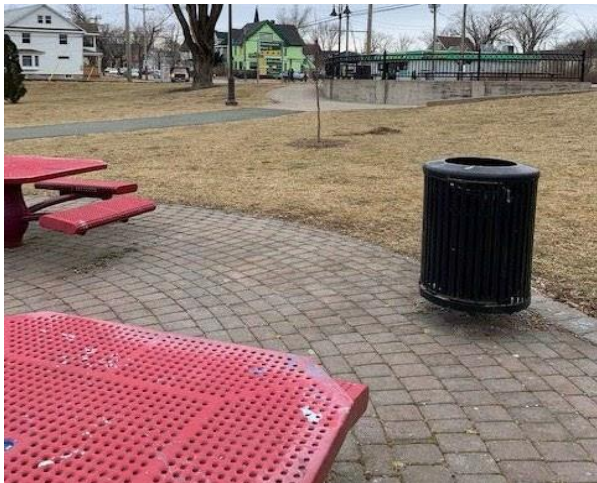
- The pathways need to have a cane detectable edge.
- There are stones and pathways near the bandshell that create an uneven pathway and create tripping hazards.
- The duck launching platforms do not have accessible access as they currently require someone to step over a barrier, this could be rectified with simple ramp structures so that everyone can participate.
- There is an electrical outlet in an area of green space, this would be a great place for a resting area so someone could charge their assistive technology and/or their electric scooter.

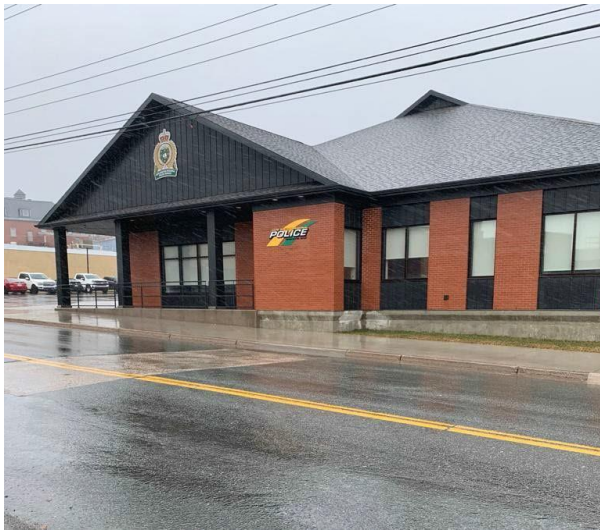
## Fire Halls & Police Stations

- No direct crosswalk access to the police station. There are curb cuts directly across from it, with no crosswalk. And a crosswalk up the road from it, with no signage identifying it. (It had apparently blown down in the weather.)
- There not much room to ensure you are out of the way when the door opens.
- The phone for emergency use outside of the station is a bit too high.

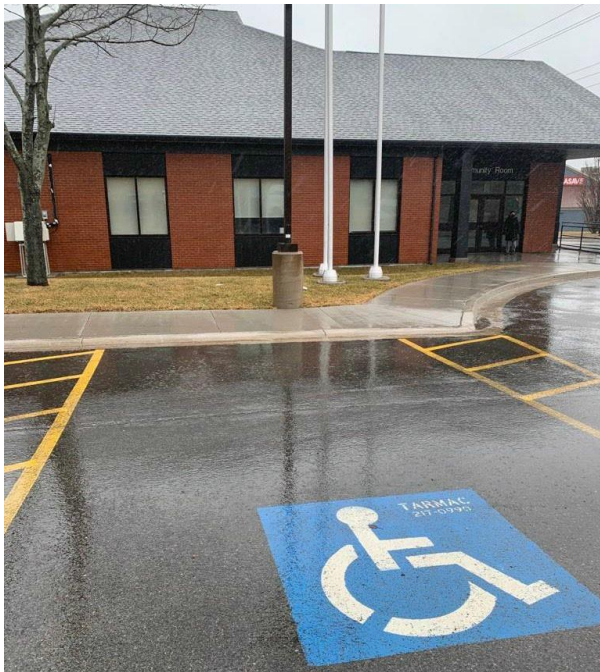
- There was no posted accessible parking sign to identify the parking space as being accessible if there was snow on the ground, or vehicles parked over the markings on the ground.
- The gender neutral accessible washroom was great to see, the only recommendations would be to have door opener buttons and to ensure that the pipes to the sink are properly insulated to prevent scalding.

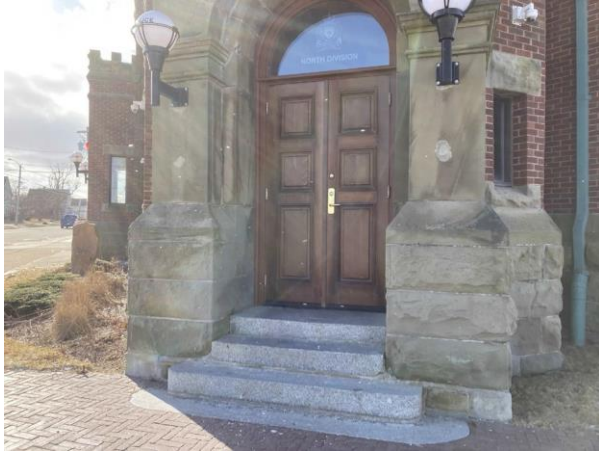
## Fire Halls & Police Stations

- Contrast needs to be added to all stairs to assist individuals with visual impairment.
- The side/back entrance was not accessible, only stairs were present.
- Barrier free parking was on the roadside creating an area of concern when transitioning from vehicle as traffic is present.

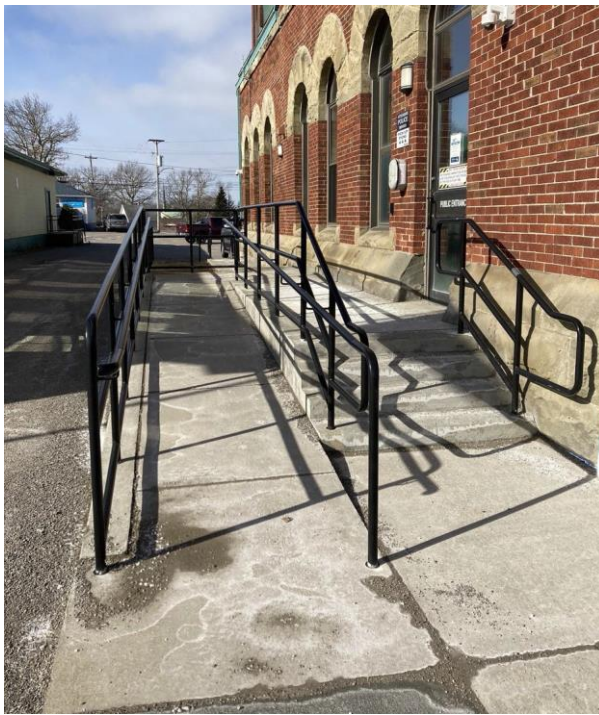
- The only room we could access was the lobby. The service window was at an appropriate height for a person using a mobility device. Plexiglass at reception makes hearing the reception officer difficult, even for persons without hearing loss. An intercom could be added that would allow the maintenance of the plexiglass shielding and mitigate communication barriers.
- The lobby had enough room to manoeuvre. A focus on a range of seating types would be a welcome addition to the space. For example, seats that provide adequate kick space to allow people to stand with ease.
- The ramp and stairs, as seen to the left, need contrast and tactile indicators.

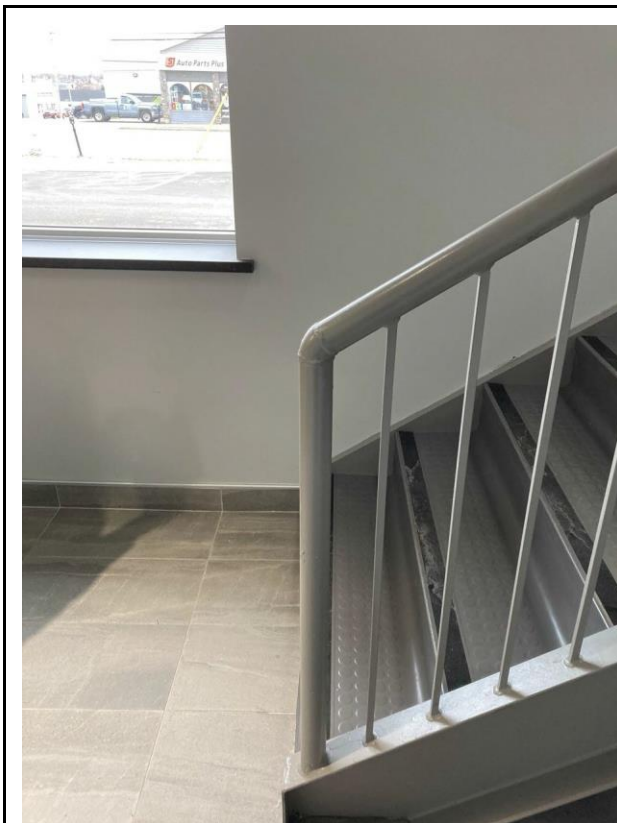
## Fire Halls & Police Stations

- The stairs, as seen to the left, require better contrast, in bright colours, and new tactile indicator strips.
- The kitchen area, which we believe is strictly for those employed at the station, does not have accessible counter workspace and a lot of over the counter storage at inaccessible heights.
- The stairs need to have railings available on both sides of the stairs.

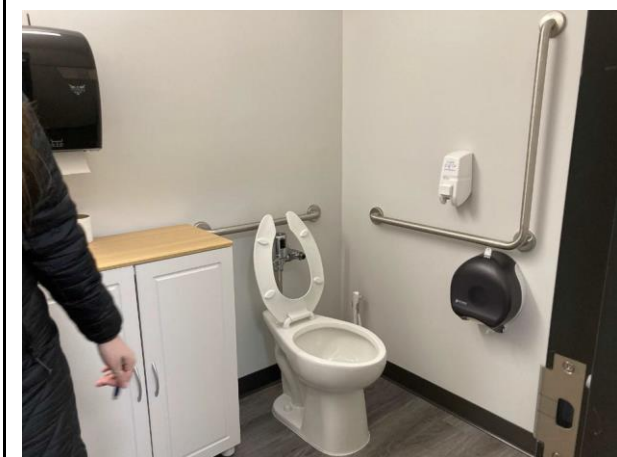
- The turn radius in the bathrooms is impeded by the moveable added storage cabinet that is located in most of the washrooms. We recommend removing this to improve upon the space provided.
- There is an elevator at this location, however they are unable to use it at this time due to some technical issues with the generator override system.
- There are no posted signs identifying the accessible parking spaces.

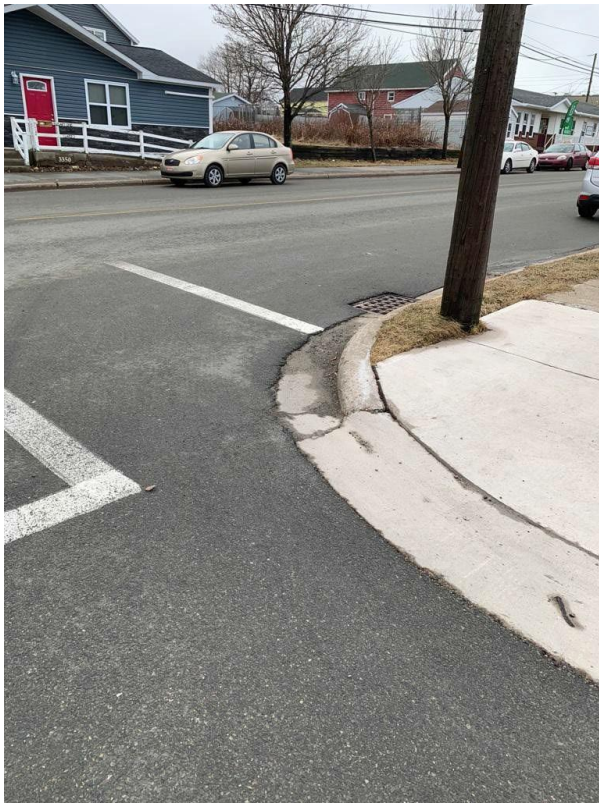
## Sidewalks, Storefronts, Signs, Public Offices

- The markings are wearing off the road.
- There are no posted signs.
- Curb cuts are either in the wrong spot or they are non-existent.
- No visual or auditory signals.
- There is no identified street side parking so cars are parked dangerously close to the crosswalk impeding on the visibility of someone walking across the crosswalk for oncoming traffic.

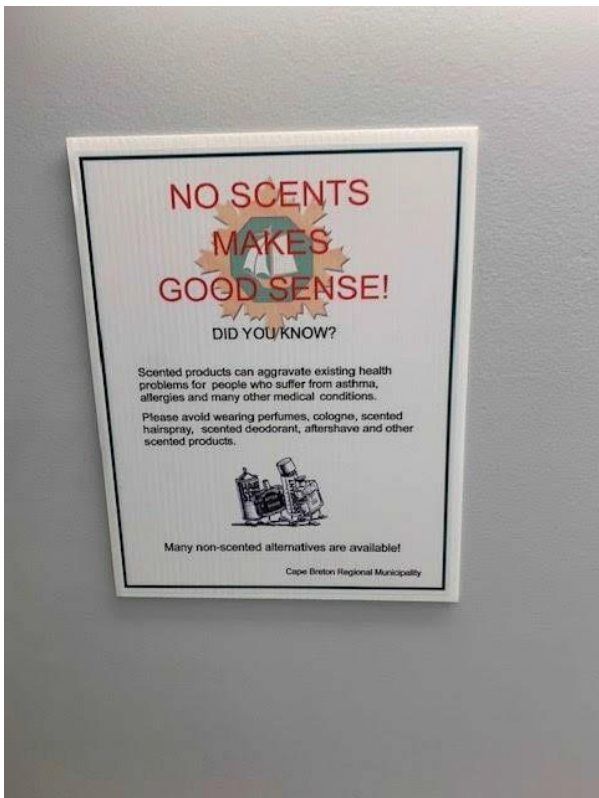
These signs were found in the Coxheath Recreation Centre, and very similar signs were found in the bathroom at the CBRM City Hall.

- Placing a smaller CBRM logo in one of the corners of the sign.
- Using black for all fonts, or atleast a more distinct shade of red, if red is necessary - this shade of red is somewhat faded.
- Ensuring all fonts are at least 16 pt.

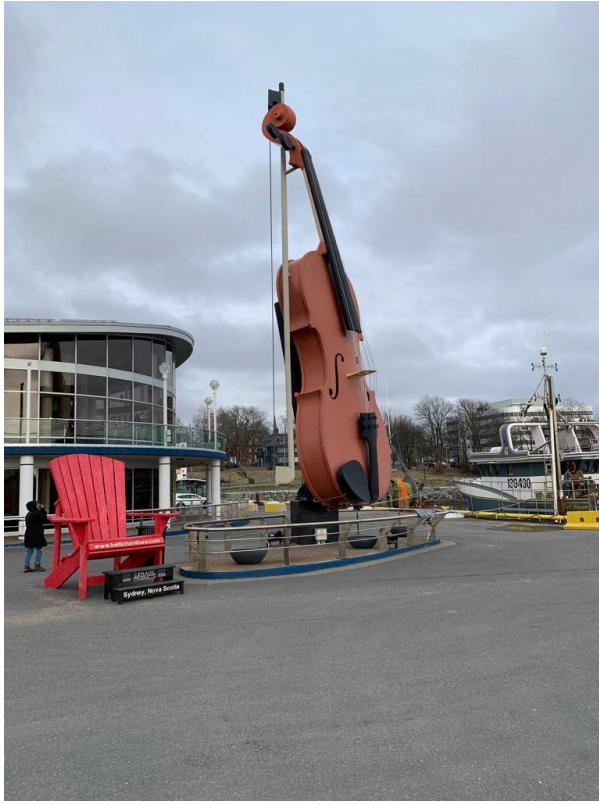
## Tourist Attractions & High Traffic Areas

- It is unclear due to lack of signage if this is a pedestrian only area or if vehicles have access to this space.
- The Big Chair next to The Big Fiddle is also a great photo opportunity, however inaccessible to anyone who requires mobility support.
- The railings around the base of The Big Fiddle are an accessible height and diameter and we were pleased to see the contrast around the base of The Big Fiddles platform.

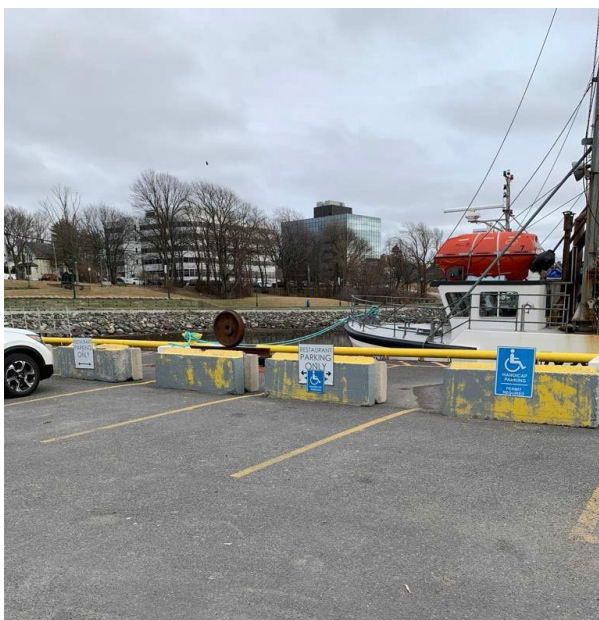
- These accessible parking spaces are not clearly marked. The posted signs should be on posts and approximately 4 feet off the ground for optimal visibility. They also require painted markings on the ground to show their accessible designation.
- There isn't any safe passage from these parking spots to the wharf, the Joan Harriss Cruise Pavilion, The Big Fiddle or anywhere as someone parking here would have to walk through the line of traffic to get to the crosswalk or any of the aforementioned places.

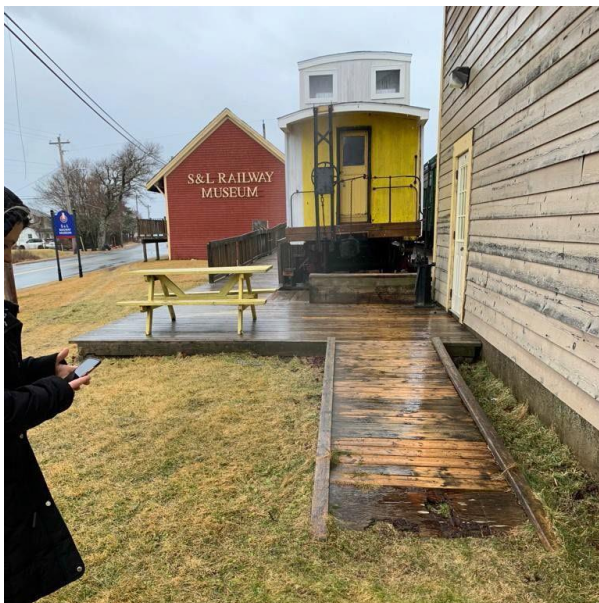
- The cane detectable railing/ledge does not cover all of the ramps or walkways. This needs to be improved.
- Any areas that are more than 200 mm off of the ground should have a railing, not just the cane detectable railing.
- The signs and information panels provided at this location do not have appropriate contrast and can get quite worn over time. Proper maintenance of these pieces is needed to ensure equitable access to this historical tourist attraction.
