## **Cape Breton Regional Municipality + You. Moving Accessibility Forward.**

**Final Accessibility Action Plan for the Cape Breton Regional Municipality (CBRM)**

**Submitted by: reachAbility Association**

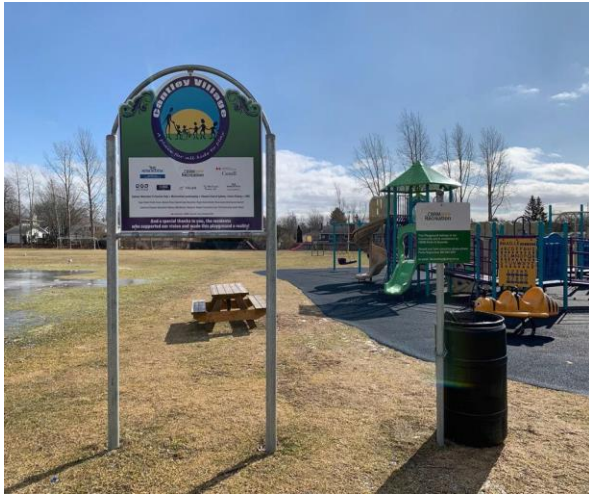
- There is no designated parking or even signage referring to parking being allowed at this location.
- The entrance from the parking lot up onto the walking trail and the fields is not accessible. It's not stable ground and is quite inclined - this could possibly be paved or the incline levelled.
- Currently there are two fields, one could easily be converted to a soccer field with the baseball field being updated so that the diamond can be used. Otherwise, we would suggest completing the fence and creating an off leash dog park for the community.
- There needs to be rest areas along the trail/path no more than 30 metres apart with ample waste receptacles also available.

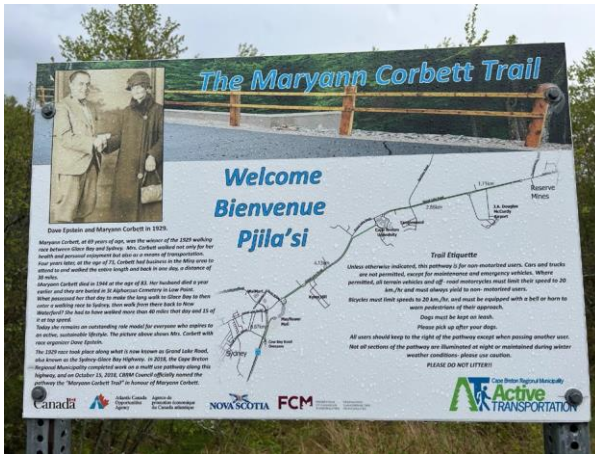
- At the entry point behind Town Hall walking along the trail, there was no signage for directions.
- No waste receptacles for garbage or washrooms that was noticed at the earlier portions of the trail connecting to the downtown corridor.
- Parking is available at various points along the trail.
